Navajo Abandoned Uranium Mine

Site Screen Report

Mine Name: Black Rock
Mine ID: 249

April 2012

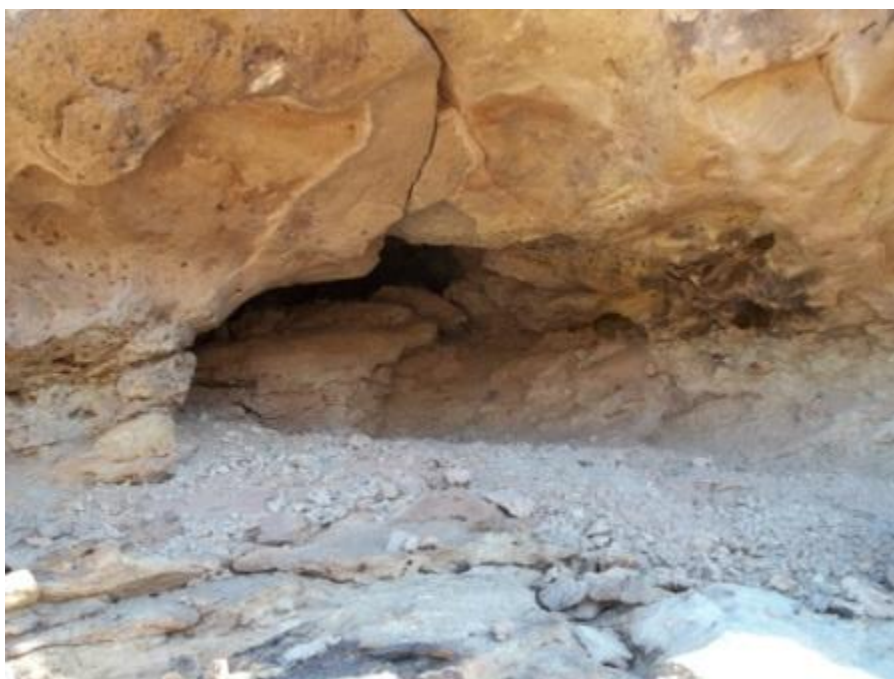
Photo 2

1 adit, red stone sealed, approximately 6' wide x 3' high

Mine Site #249 - Adit

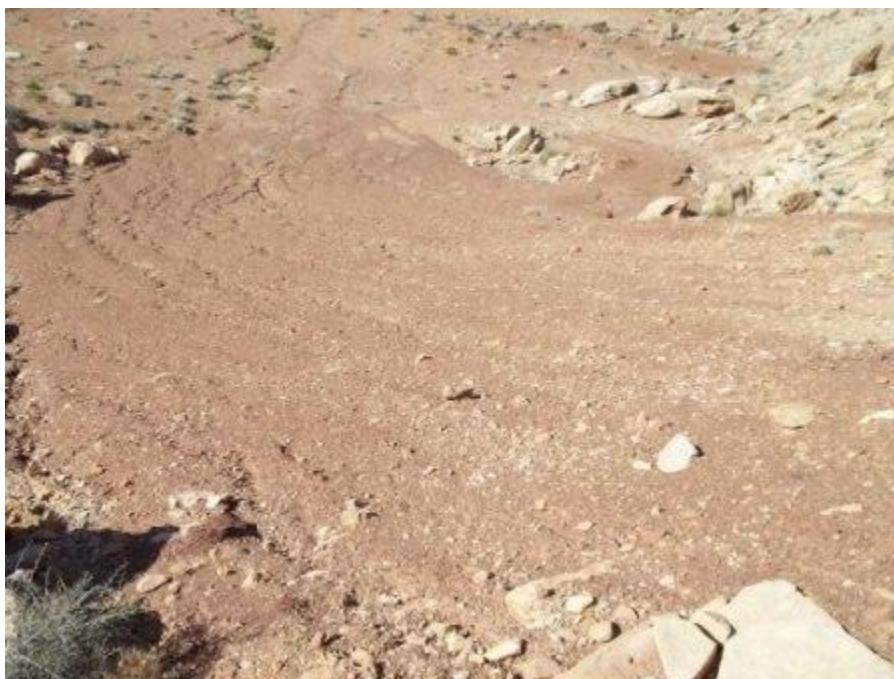
Photo 3

Reclamation cap / tailings area, red clay, with drainage west toward Route 163, 50' wide x 100' long

Mine Site #249 - Cap
